# **TEST REPORT**

Lucideon Reference:	UK233535 (QT-72418/2/JB)/Ref. 1/CR1
Project Title:	Determination of the Resistance to Wind Up-Lift of Buzon UK Ltd's Porcelain Decking Systems
Client:	Buzon UK Ltd Unit 6 Teddington Business Park Station Road Teddington Middlesex TW11 9BQ
For the Attention of:	Mr Mike Wilderink
Author(s):	Mr Justin Fryer
Report Date:	20 December, 2023
Purchase Order No.:	1322

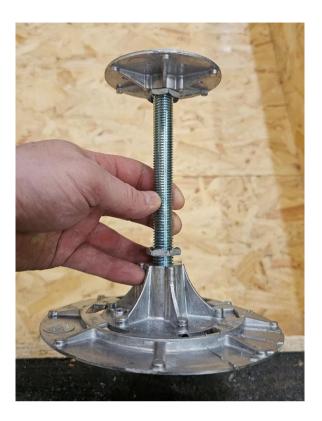
Plate 1 – Buzon A-PED Pedestal

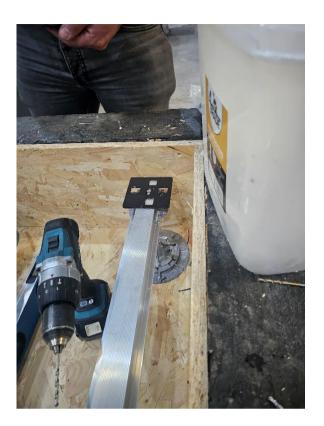
Plate 7 – Buzon A-PED-JOIST with Buzon A-PED Pedestal and Buzon A-PED-TABS-PLATE

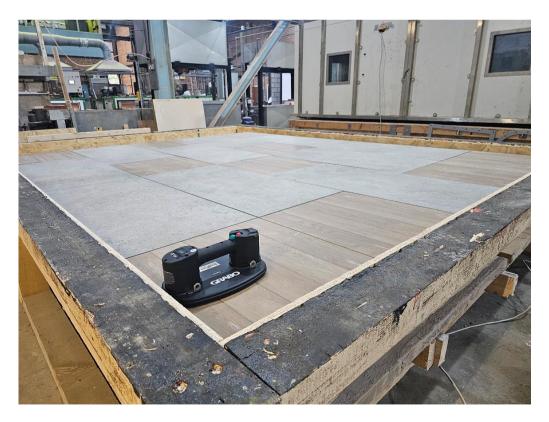
Plate 8 - Sample Completed Dry (no adhesive)

The sample was constructed dry (without adhesive) first in order to ensure the installation was correct and level.

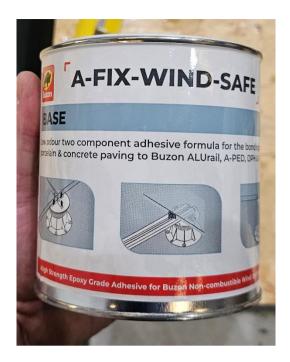
Plate 9 - Buzon A-FIX-WIND-SAFE Adhesive

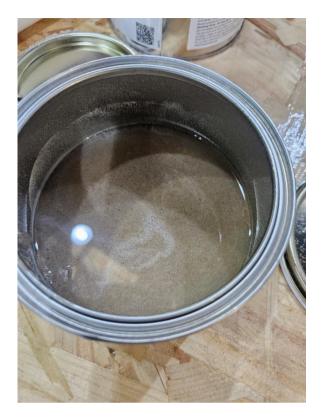
Plate 11 - Hardener (Part 2) of the 2-Part Adhesive

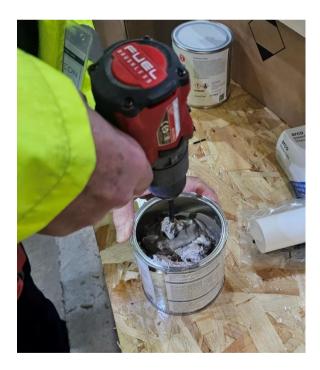
Plate 12 - Adhesive Mixed using Plastic Paddle Attached to Drill

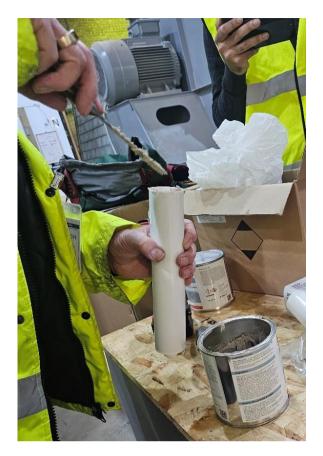
Plate 13 - Mixed Adhesive Transferred into a Plastic Tube

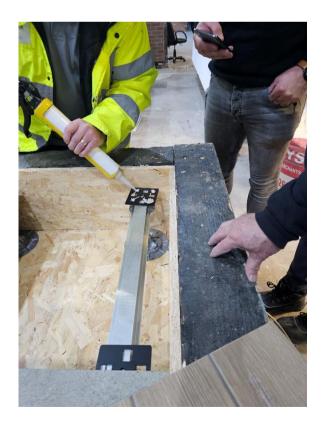
Plate 14 - Adhesive Applied to Tile Spacer/Pedestal Tops

Once installed to the Buzon representatives satisfaction, each tile in turn was lifted using a Grabo Electric Vacuum Lifter, and either a small line of the adhesive was applied to the pedestal corner beneath the tile, or a single line along the top of the rail or joist beneath the tile was applied, the tile was then replaced and compressed slightly before repeating on each subsequent tile, until such time, as all but two tiles were adhered to their respective pedestals and/or rail/joist.

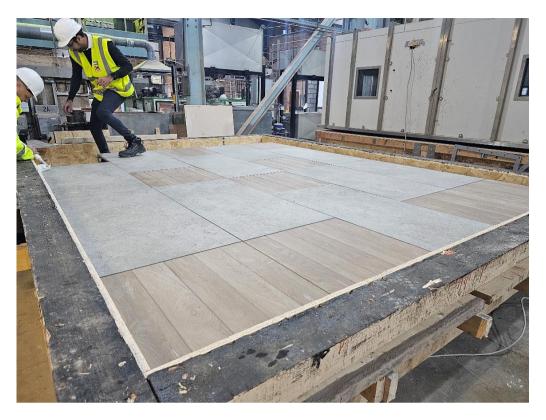
Plate 15 - Completed Test Sample

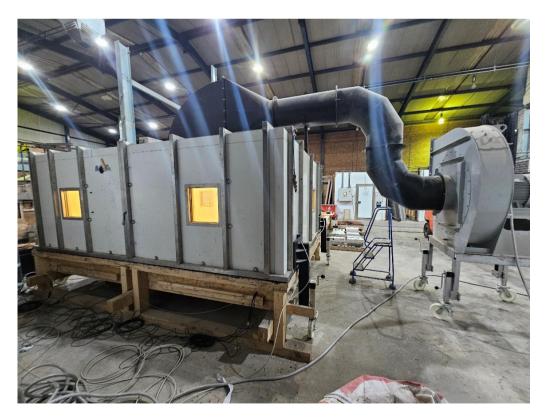
Plate 16 - Sample Within the Test Rig

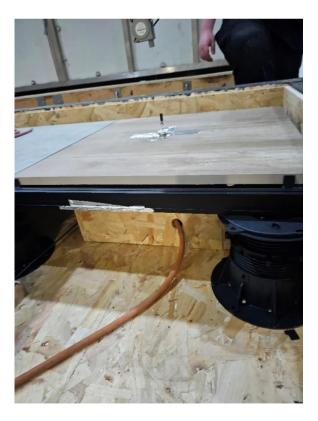
Plate 18 - Static Load Test Set-Up (2)

A box was constructed using plywood, of nominal dimension 400 mm x 400 mm x 180 mm (W x L x H), which fit underneath the tiles and between the pedestals.

An airbag was placed within the box and connected to a common manifold by way of a rubber pipe.

A scaffold framework was constructed, such that, an LVDT could be positioned directly above the geometric centre of the tile to be tested. The LVDT was connected to the tile, by way of a steel washer secured with duct tape and a strong magnet.

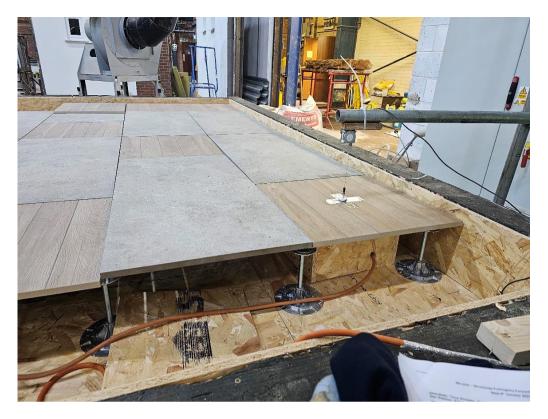
Plate 19 - Tiles Lifting During Load Testing

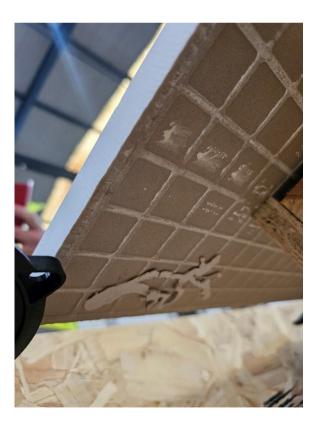
Plate 22 - Typical Failure Beneath the Tile (debonding of the adhesive from the pedestal)

Maximum Load		Deflection @			
System	Ра	kg/m²	Max Load (mm)	Failure Mode	Comments	
Buzon A-PED	30490	3109.07	49.64	Debonding of the	The tile lifted the pedestals at	
Buzon DPH	11420	1164.50	14.64	adhesive layer from the pedestal	the free edge and de-bonded from the tiles adhered to further tiles	
Buzon A-PED-JOIST	37960	3870.78		Larger 1200 mm tiles further		
Buzon U-BRS-38MM Rail	87530	8925.43	60.59	section until adhered area to the bottom face of the tile sheared from the tile	along the railed section de- bonded in a peeling manner due to the lift of the rail
